Project of the month

How does a Natural Swimming Pool work?

BioNova Historical

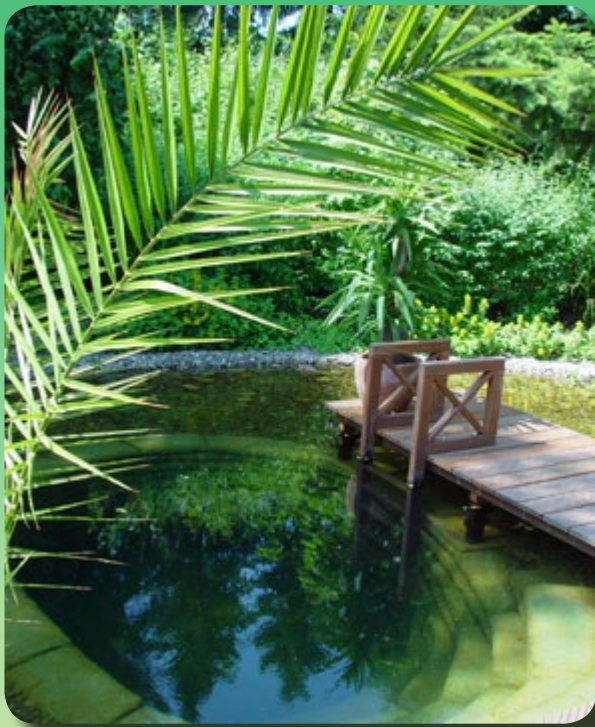
Our long-time partner "Garten- und Landschaftsbau Zinke" based in Arenshausen (Thuringia / Germany) has proven since 2002 that lack of space is no reason to go without an NSP. He answered his client's requests for a little vacation paradise in his own yard in Northeim (Lower Saxony / Germany) by building a small BioNova Minipool that measures only 614 ft².

Swimming area and regeneration zone are not separated in this pool. The oval swimming area is about 6 ½ ft. deep, bordered by granite stones and surrounded by the planted regeneration area, where the used water is cleaned purely by biological processes, without chemicals. Overflow gutters, fine filter and a small circulation pump provide a little added filtration help.

Traverse the regeneration area over a footbridge to the swimming area where a small wooden terrace invites you to relax and stay awhile. Go on vacation - at home - anytime you like!

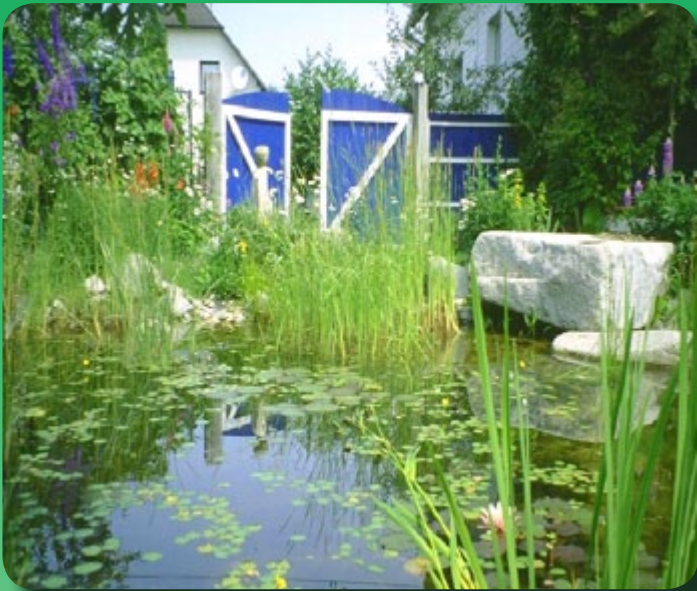
Perhaps you have already wondered how water treatment could work without any chemicals. As promised in our last newsletter, we will start to better explain the technical functions of an NSP. For this purpose it is necessary to impart some basic scientific knowledge, seeing as the BioNova System is grounded on the principles of limnology, or the science of fresh-water systems.

Natural swimming and bathing pools basically work by the same ecological processes that occur in natural lakes. As in every ecological system, the natural balance of individual components is very important. In case of a natural swimming pool, it is the perfect balance between phytoplankton (algae in the broadest sense) and zooplankton (microorganisms) that

matters most. Natural processes occurring here are further supported by water plants, filters and mechanic cleaning, so that the system can still remain stable at periods of high stress on water quality (high numbers of visitors, changes in temperature, great heat, etc.).

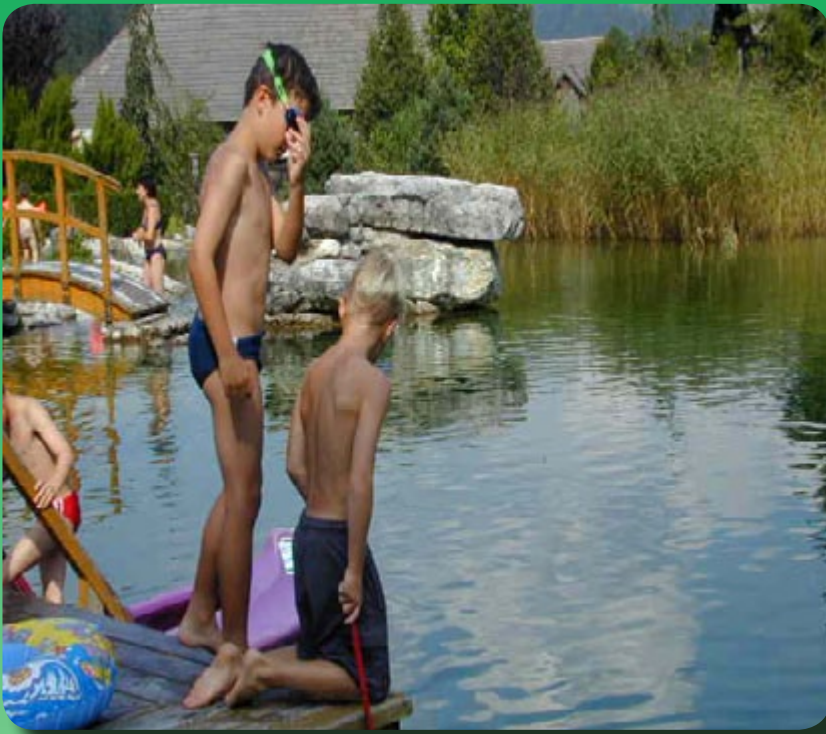
In 1995, an NSP was built for the hotel Dietlgut at Hinterstoder (Austria) according to the latest state-of-the-art techniques. The NSP is 197 ft long and 12 ft deep at the deepest part so that it has a total water volume of 9688 ft³. 4306 ft² of that can be used for swimming and bathing and 4382 ft² are planted regeneration area.

According to the marketing concept of the „child-friendly hotel“ the owners wanted to offer their younger guests a natural swimming experience in chemical free water. So the BioNova team replaced the 40 x 26 ft² chlorinated pool with a natural swimming pool.

the building method and the size of the NSP. Swimming area and regeneration area were separated, with a floor level difference of about 5 feet. The aim was to ensure unimpeded progress of the natural cleaning processes even on very hot days or days with more bathers than usual.

For the so called 2-pot-building-method, there are two water basins. One is used as a swimming and bathing pool, totally free of plants or animals. The other one, the regeneration area, is used for water treatment. It looks like a green oasis and the guests love to relax in the natural atmosphere. But the work of water treatment also takes place here: the used water from the swimming area is pumped into the regeneration area and treated with the help of the water plants and a Bio-filter, and is oxygenated without using any chemicals. The fresh, clear water is then pumped back into the swimming zone.
